**HRRVC Western Holiday Pusher
Chapter 500**

Volume 10, Issue 1

March 2011

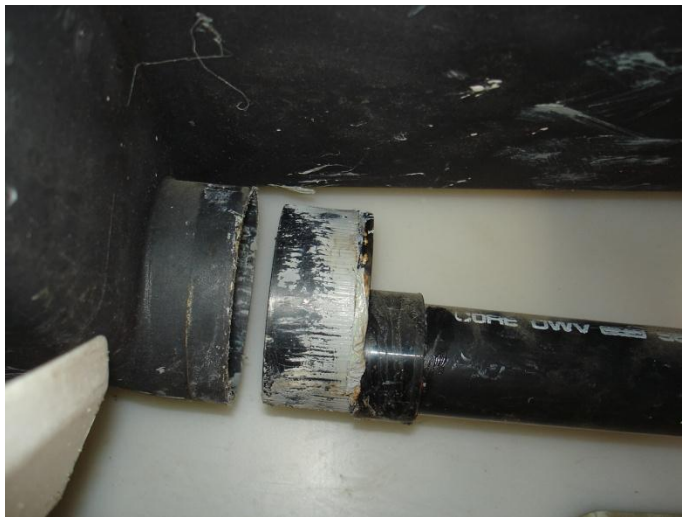
Problem: slight leak (drip) from the pipe exiting the grey water tank.

Solution: Initially, I thought it was the joint of the 3 ½ inch fitting from the holding tank but after I removed that section, cleaned it and put it back together, I found it was the 3 ½ inch to 1 ½ inch reducer that had the leak (probably a hairline crack). I could not see the actual crack but noted where the water was leaking so I purchased a small tube of EP-200 epoxy putty (\$4 at Home Depot) and applied it to both sides of the reducer. The epoxy was easy to use and cured in 10 minutes to a hard compound that stuck to the inside and outside of the reducer. After putting copious amounts of pipe thread sealant around the holding tank coupling, I put it back together, tightened the hose clamp and it seems not to be leaking.

It was easy to remove the piping between the holding tank and T handle dump valve – just remove all four screws holding the dump valve in place and wiggle the assembly out of the holding tank coupling.
